C & V SURVEY Condition & Valuation

Date of report: June 24th 2008
Our file #: 08 - 26240

Builder:	Ta Yang Yacht Bldg. Co. Ltd	Doc. #:	656685
Model/type:	FD-12	Engine/MFG:	Lehman (Peugeot) 4D-61
Year:	1981	H.P. per:	61
Length:	50.3'	Serial number:	315138
Draft:	6.5'	Type of instal. :	Diesel, 4-cylinders, inboard, freshwater cooled
Beam:	14.25'	Generator:	4.3 KW Entec
Name:	"Daydreamer"	Hailing Port:	Anchorage, AK
HIN:	TYA510200881	Displacement:	36,000 lbs.

John & Dianne Olson, Our File # 08-26240, 1981 50.3' TaYang Yacht Bldg. – “Day Dreamer”

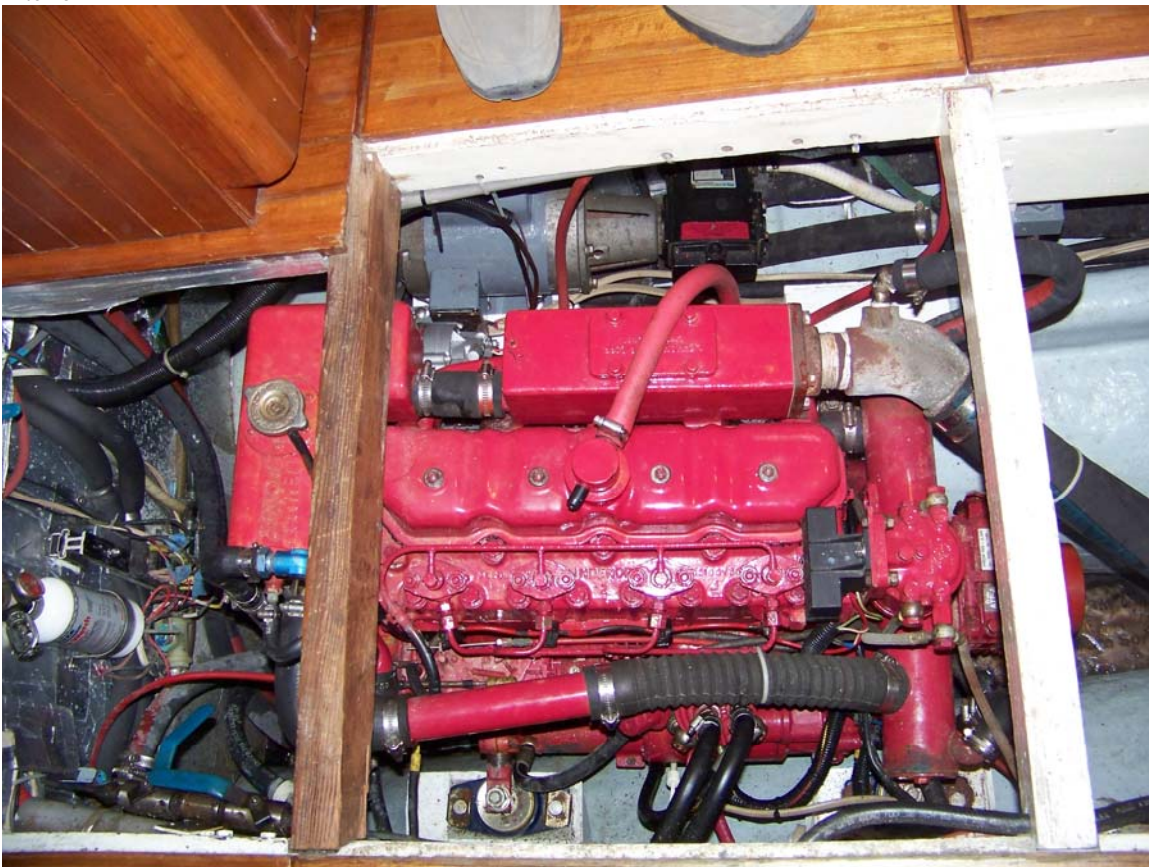
Engine's external surfaces appear good and exhibit no rust, oil or coolant leaks. Engine hour meter exhibits 355-hours. Motor mounts appear good. Cooling system appears good. Fuel system and components appear good. Exhaust system and components appear good. Electrical system and components appear good. Engine control system appears good and shaft log appears good. Steering control system appears satisfactory and rudder port appears satisfactory. The propeller shaft is out and being serviced. Generator surfaces and motor mounts appear satisfactory -good. Generator's peripheral components and systems appear satisfactory – good. Waste system and components appear satisfactory – good. General service seawater systems appear satisfactory – good.

2. Service the corrosion on the engine's vented loop. Specifically prevent any weeps or leaks through the exhaust system. Clean the corrosion to allow detection of any future weeps or leaks.
